I.2. Getriebe schaltet "automatisch"

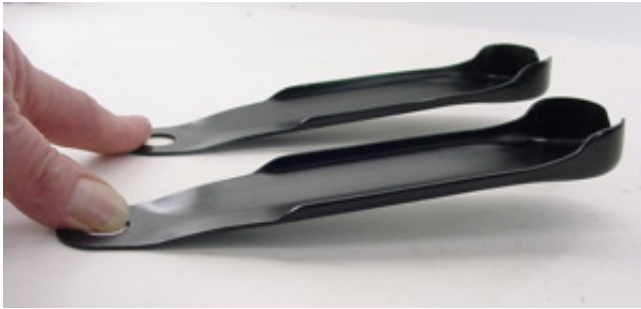
If a Schlumpf drive shifts from one into the other gear without activating a gear shift button, the reason often is an unequal pretension of the kickplates (easy-shift levers).

These levers are slightly preloaded to prevent them from "rattle" on the crank surface. The amount of preload is shown on the photo on the right.

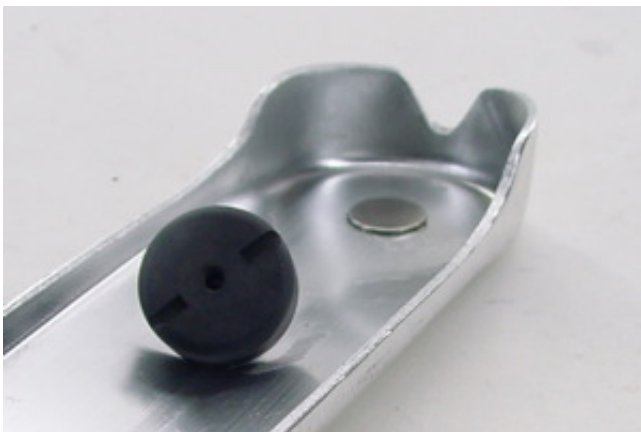
Good News: From February 2012 we will deliver kickplates with a modified fixation: they are still clamped between pedal and crankarm but are equipped with a solenoid, which acts on a steel gear shift button. Therefore no need to preload the kickplates and no danger of unexpected shifting!

If you want to replace old kickplates, you can exchange the gear shift buttons and mount two steel buttons (black colour -> photo on the right) together with the new kickplates with a solenoid inside.
